NATIONAL BUREAU OF STANDARDS REPORT

3325

REPORT ON
INSPECTION AND TESTS OF PLASTER
ALASKA NATIVE SERVICE HOSPITAL AND QUARTERS BUILDINGS

for the
BUREAU OF INDIAN AFFAIRS
U.S. DEPT. OF THE INTERIOR

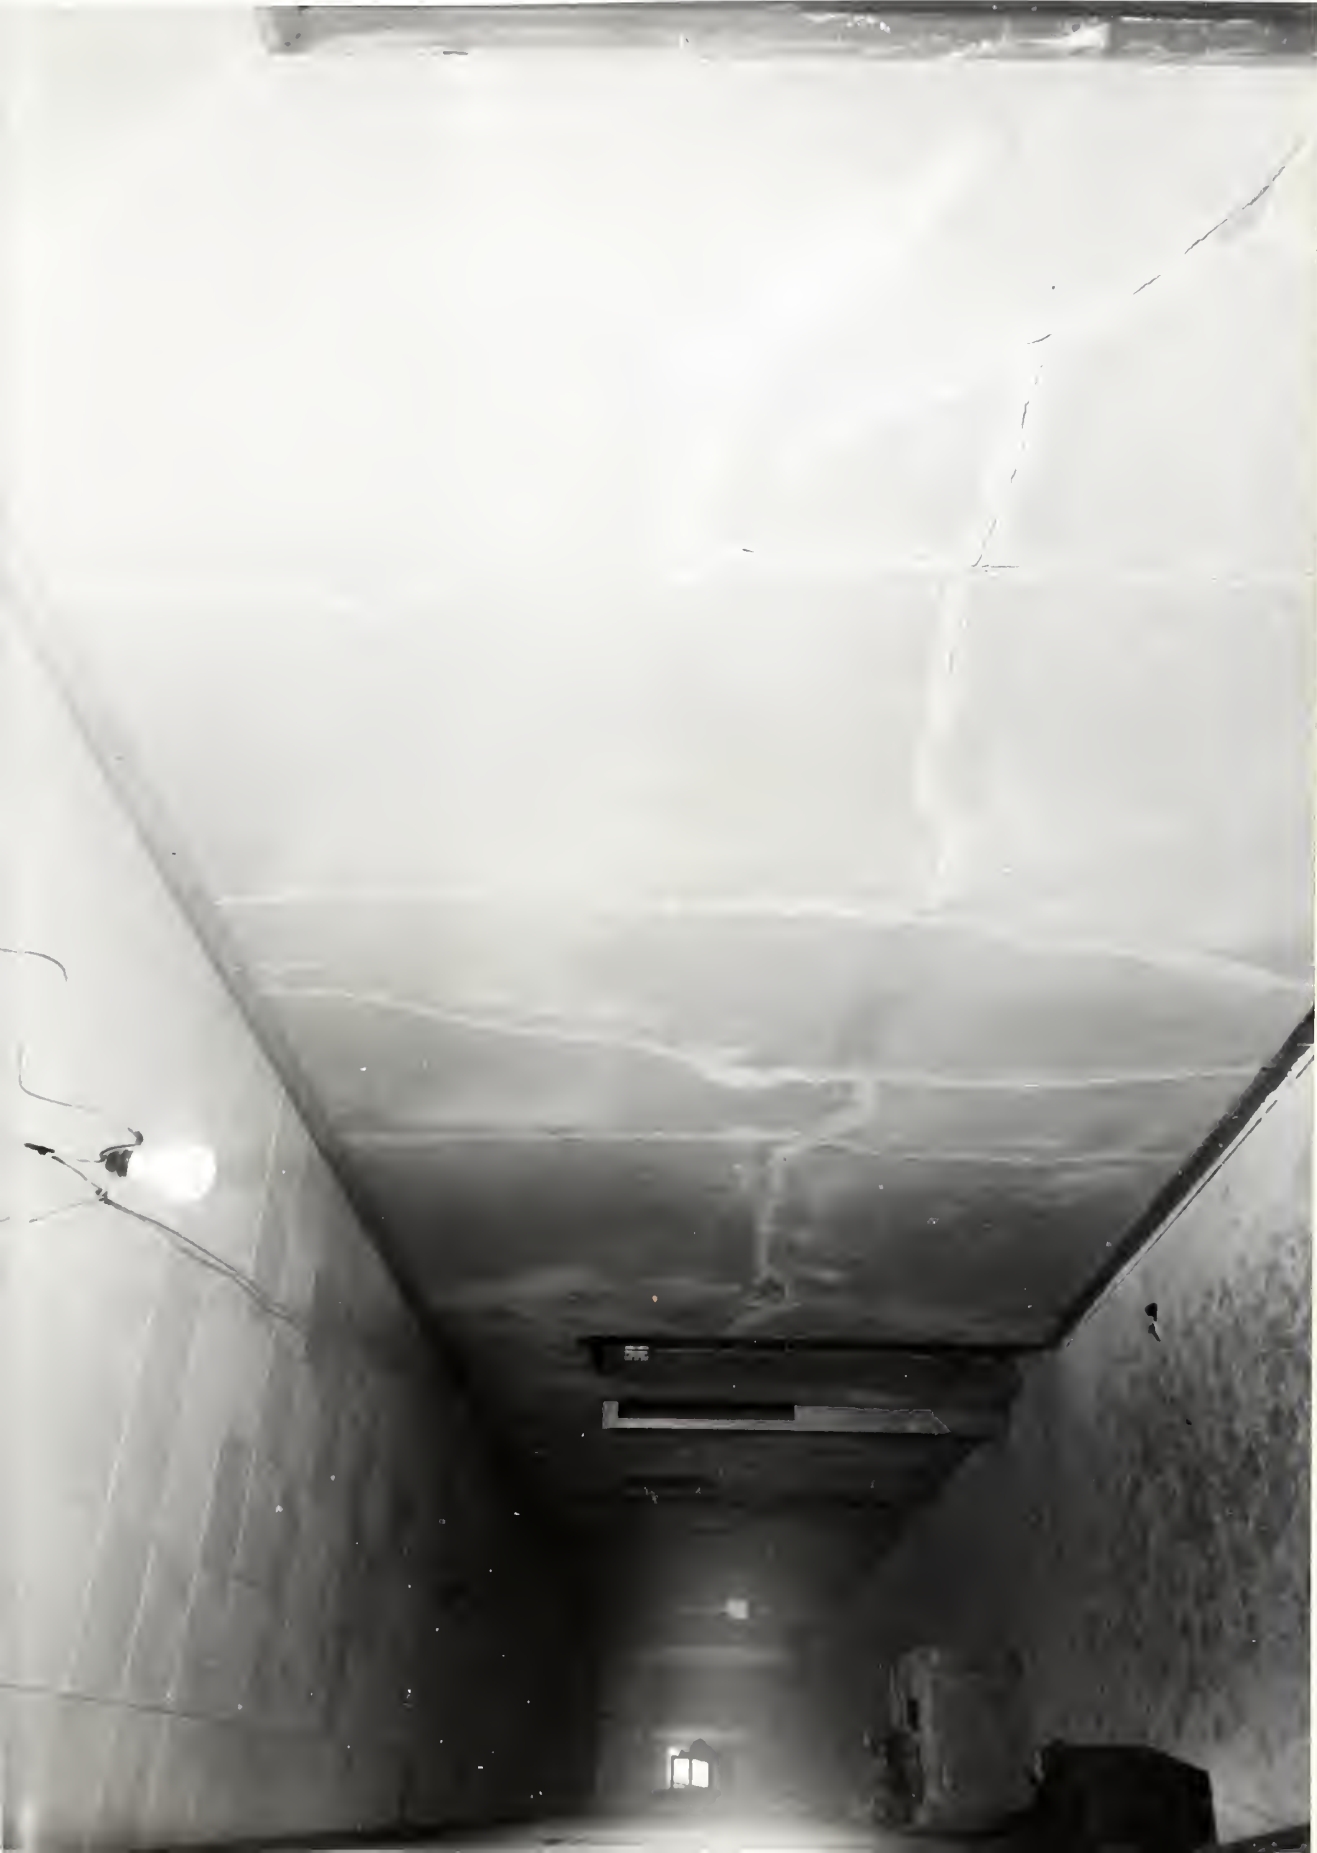
FIGURE 11. PROJECT 501-228A. PATTERN OF CRACKING IN THE WALL OF THE NORTH-WING CORRIDOR, SECOND FLOOR OF QUARTERS BUILDING ON NOVEMBER 17, 1952. THIS WAS TYPICAL OF CRACKS IN THE CORRIDOR PARTITIONS.

ANCHORAGE QUARTERS - PROJECT 501-228A
2nd floor, north wing corridor
east wall, taken November 17, 1952

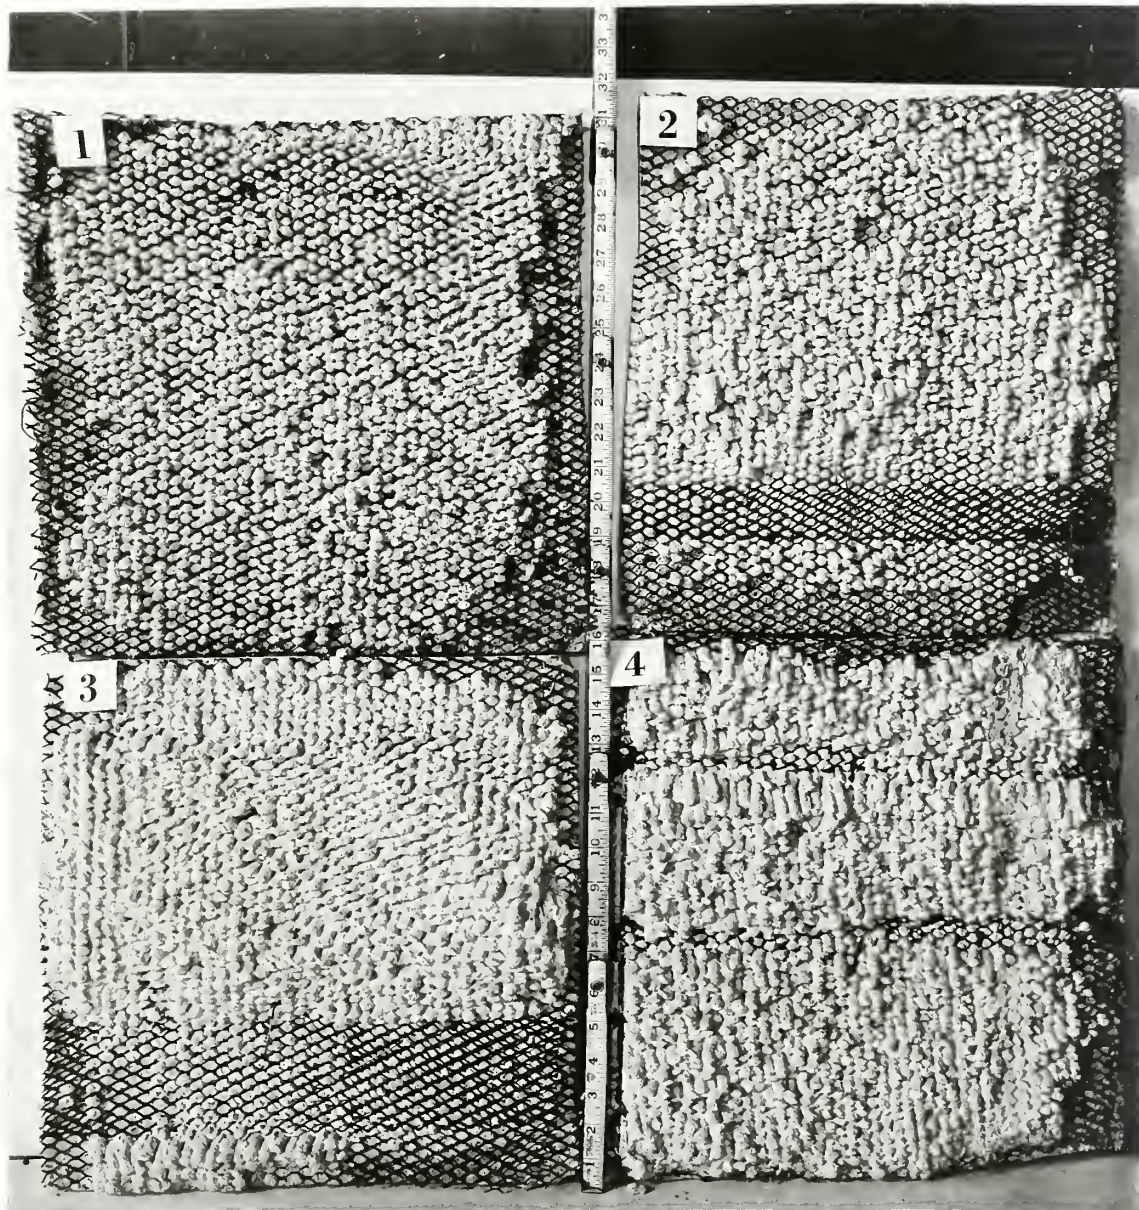
FIGURE 12. PROJECT 501-228. SPECIMENS OF PLASTER FROM WALLS OF (1) ROOM W-318, (2) CORRIDOR WALL OF BASEMENT BETWEEN DOORS OF ROOMS 7 AND 8, (3) ROOM W-182, AND (4) LINEN CLOSET S523 SHOWING PLASTER KEYS.

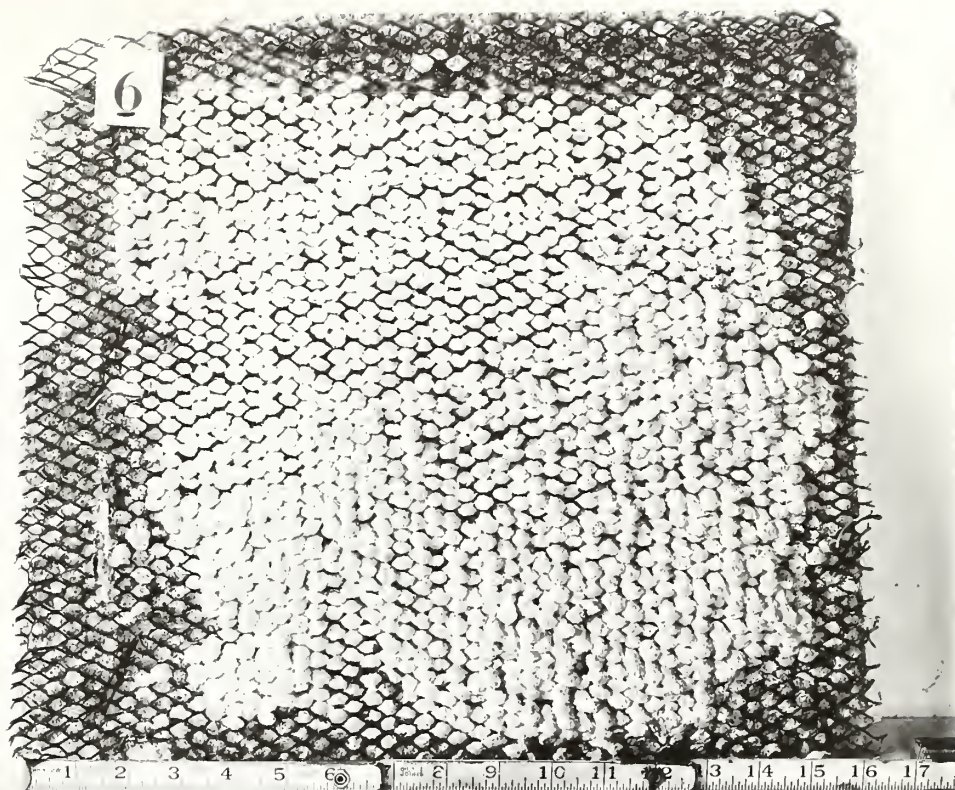
FIGURE 13. PROJECT 501-228. SPECIMEN OF LATH AND PLASTER TAKEN FROM WALL OF LINEN CLOSET N-308 SHOWING WHERE KEYS ARE BROKEN HOW RUST STAINS PENETRATE PLASTER KEYS.

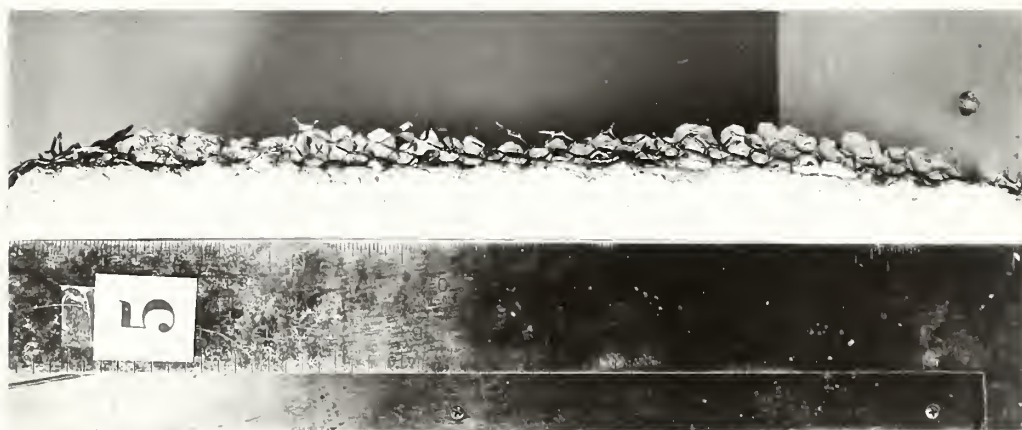
FIGURE 14. PROJECT 501-228. EDGE VIEW OF SPECIMEN FROM LINEN CLOSET SHOWING CURVATURE OF SURFACE AND THICKNESS OF PLASTER.

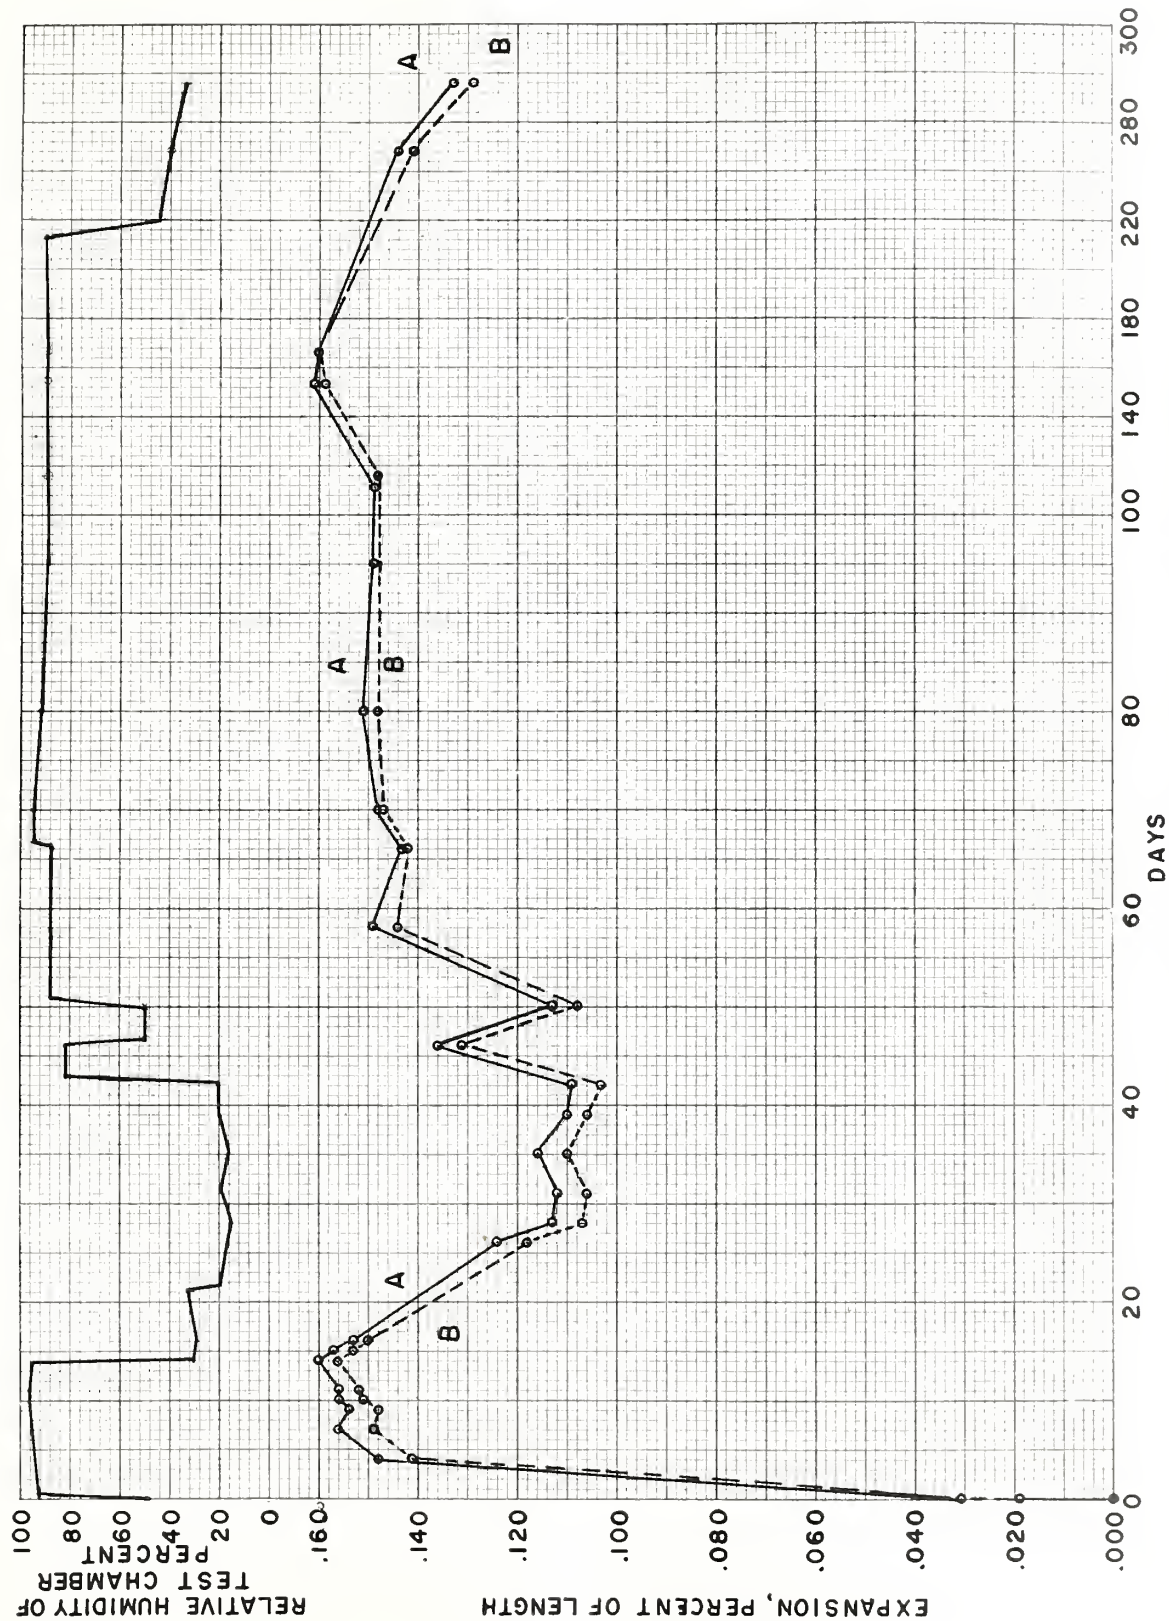
and B had increased in length by 0.130 and 0.156 percent, respectively, in two weeks. The bars were then placed in a chamber, the relative humidity of which ranged from 30 to 18 percent, for the next four weeks. During the first two weeks of this period, the length of the bars decreased by 0.046 and 0.048 percent, respectively. During the next two weeks, the shrinkage in length of each amounted to 0.007 percent. The subsequent changes in conditions of storage and lengths of bars are shown by the graph, figure 15.

FIGURE 15. EXPANSION AND CONTRACTION OF BARS OF VERMICULITE-SAND-GYPSUM PLASTER WITH CHANGES IN THE HUMIDITY OF THE ATMOSPHERE OF THE STORAGE CHAMBER.

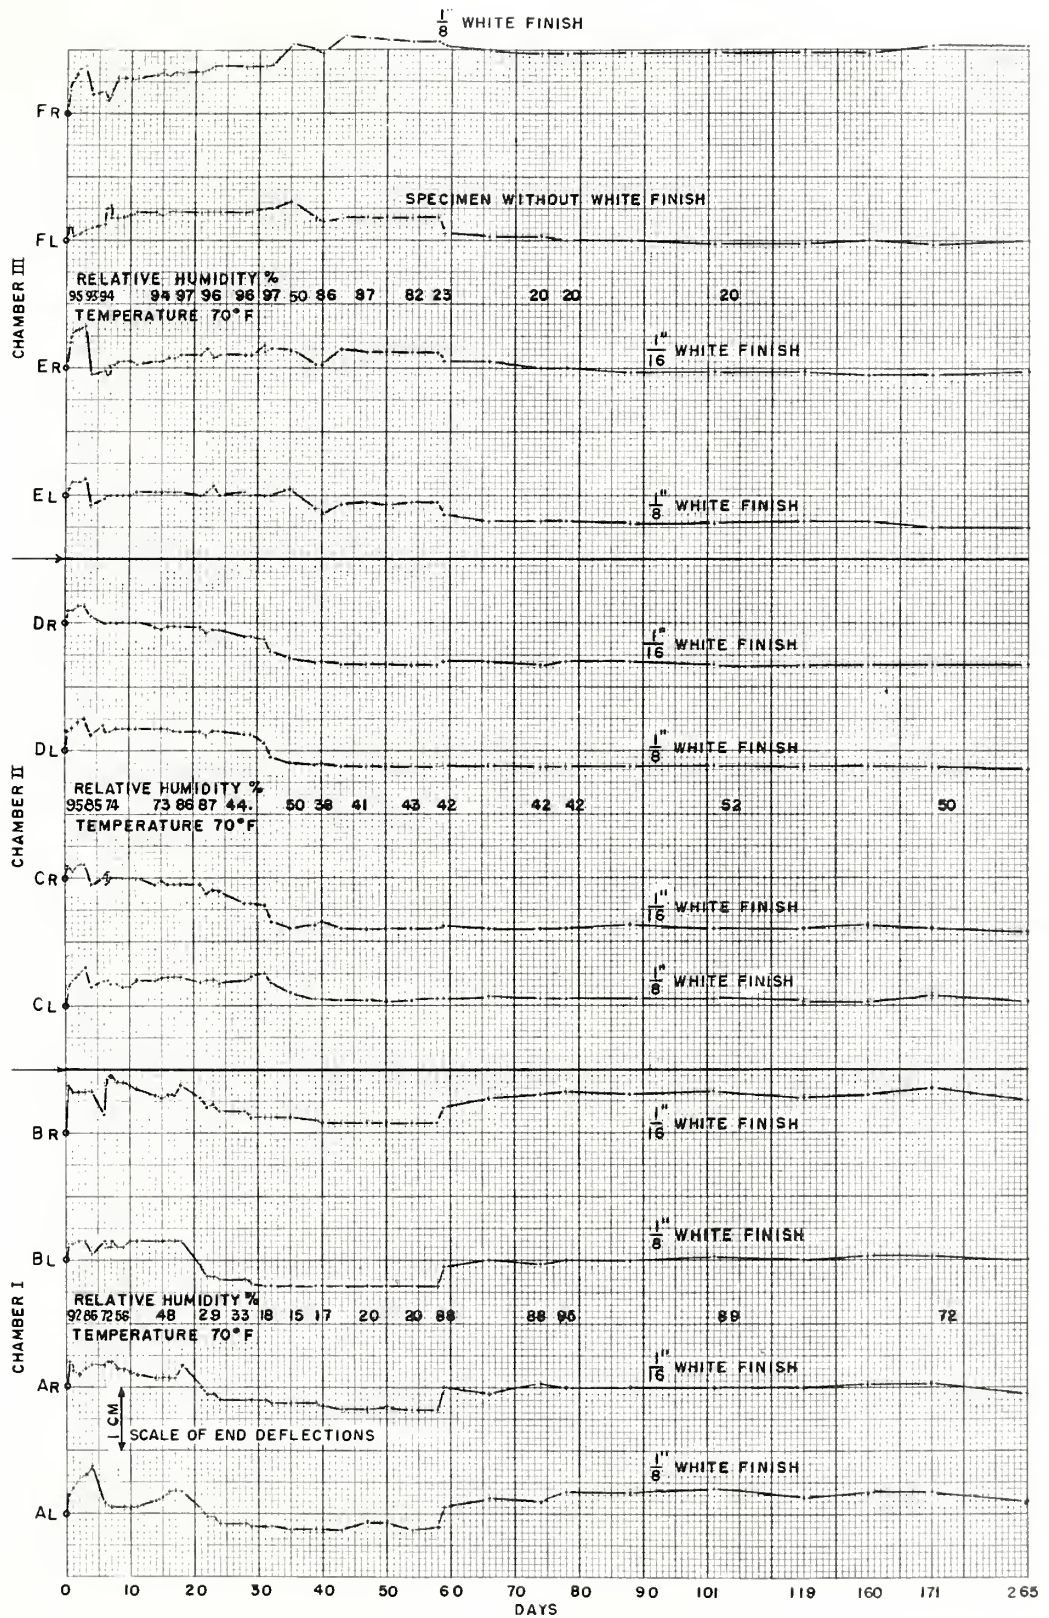
FIGURE 17. FLEXING OF LATH AND PLASTER SPECIMENS RESULTING FROM CHANGES IN THE RELATIVE HUMIDITY OF STORAGE CHAMBERS HELD AT 70°F. SEE FIGURE 16 FOR MOUNTING OF SPECIMENS.

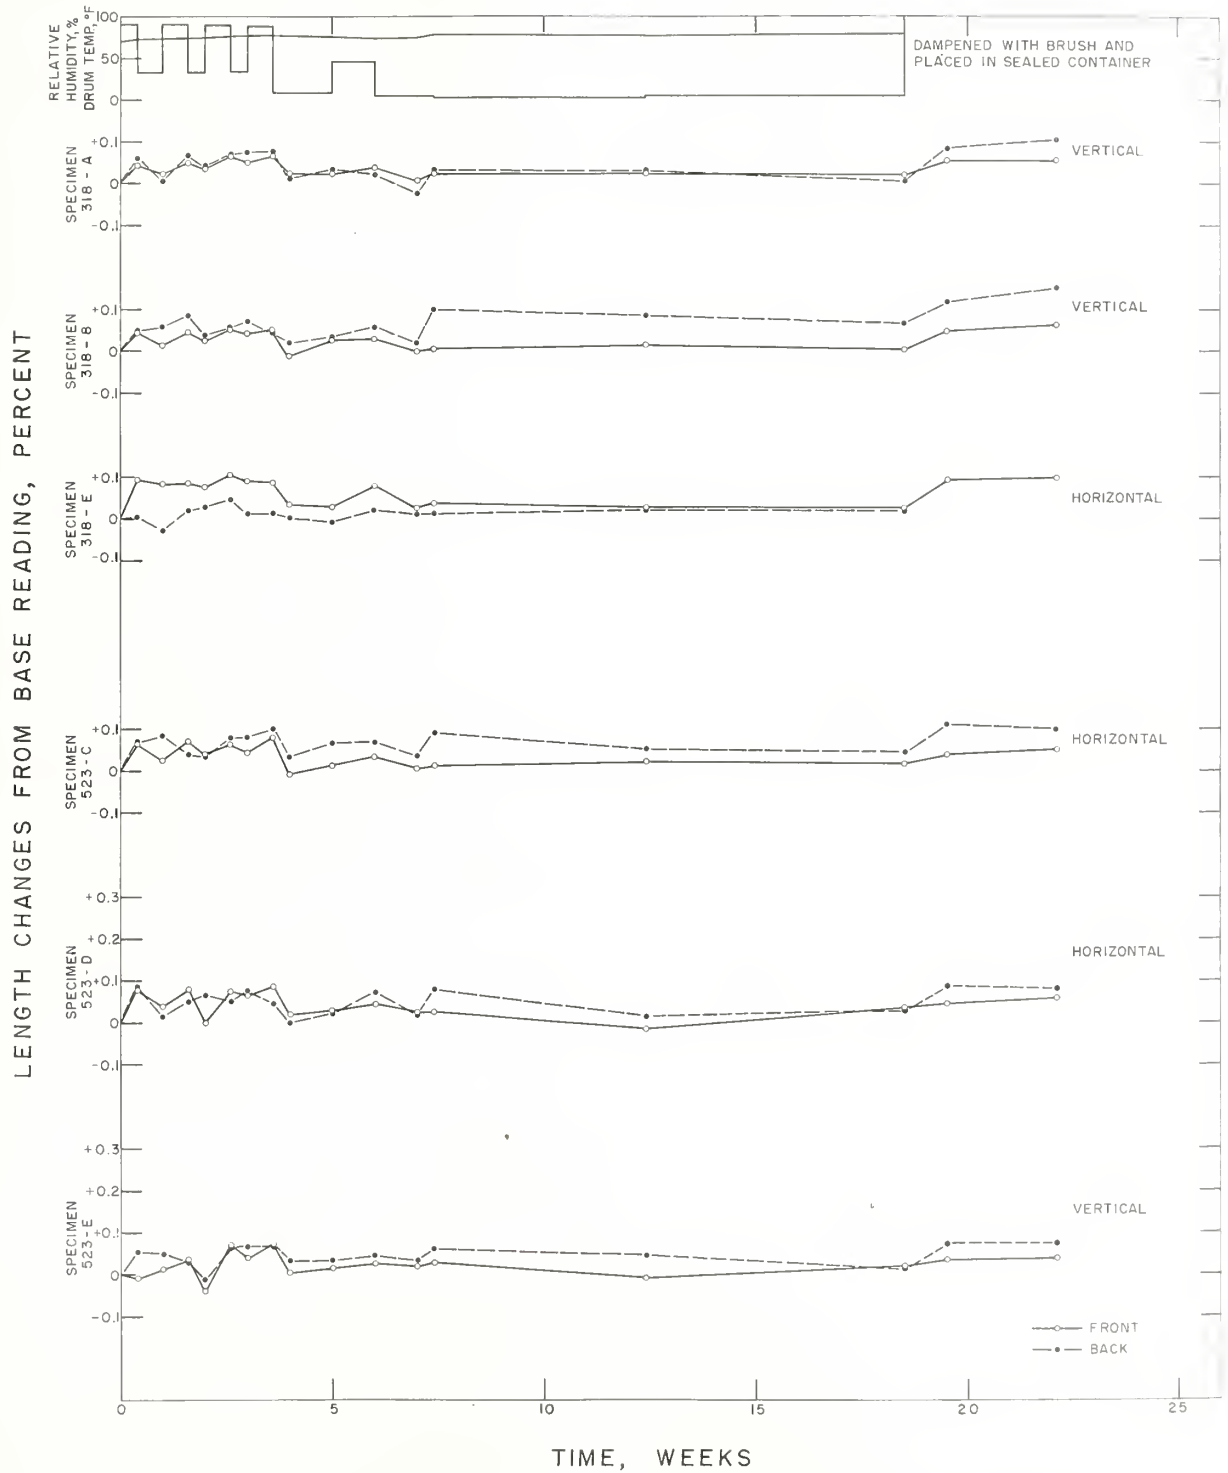
It will be observed that the lengths of the specimens were usually increased with increases in relative humidity and decreased when the humidity was lowered. When dampened at $18\frac{1}{2}$ weeks, the expansion brought the length up to approximately the same state as was reached in the earlier stages of the test under the influence of high relative humidity.

FIGURE 13. EXPANSION AND CONTRACTION OF LATH AND PLASTER SPECIMENS FROM HOSPITAL BUILDING AS THE RESULT OF CHANGE IN RELATIVE HUMIDITY AND DAMPENING. THE NUMBERS OF SPECIMENS CORRESPOND TO THE ROOM LOCATIONS SHOWN ON THE BUILDING PLAN.

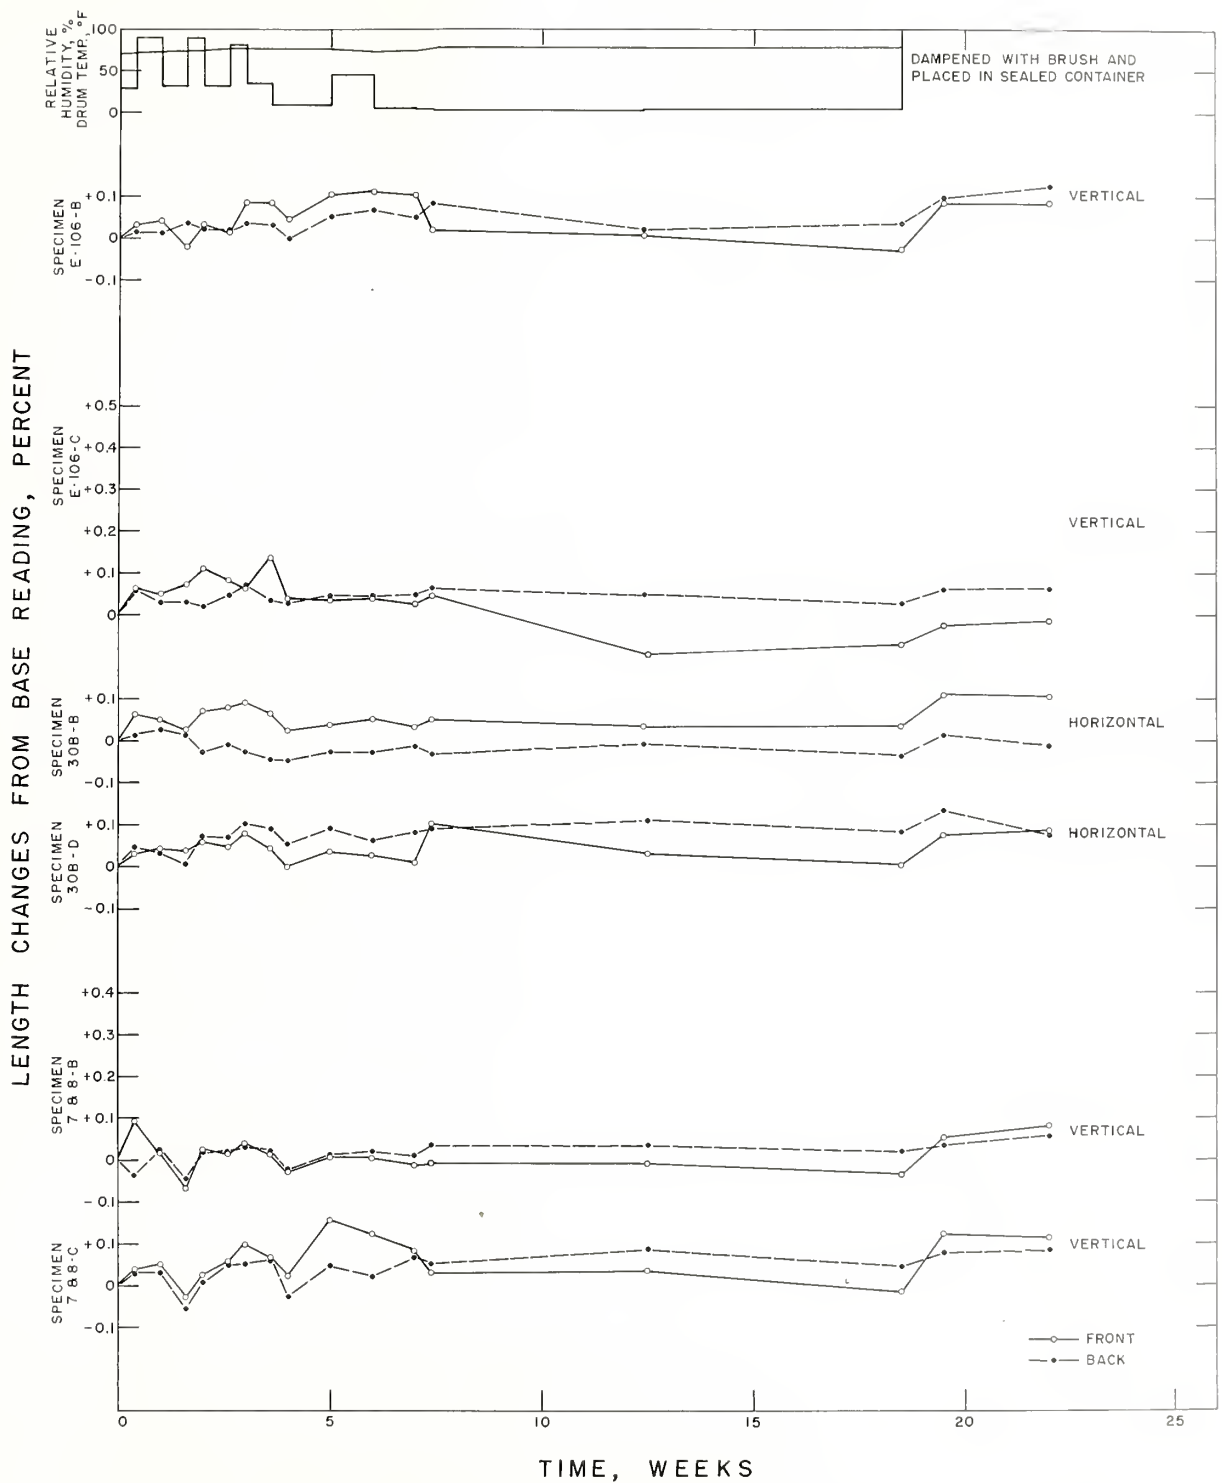
Certain anomalies are apparent in the graphs. For example, although the relative humidity of the chamber (Fig. 19) was about 30 percent, the average increase in the lengths of the specimens was approximately 0.05 percent. An exception to this trend was the shrinkage on the key side of the specimen marked 7 & 8C which showed a slight decrease in length. The general trend was for expansion of the plaster when exposed to high relative humidity, and shrinkage when the humidity was lowered. Some of the anomalies can be attributed to internal cracking of the plaster when the strains induced between the plaster and lath could no longer be resisted by the plaster. There was no decided difference in the deformations of the specimens cut in horizontal strips, length-wise of the lath, in comparison with those cut vertically, that is, transversely to the lath. The deformations on the back or key side of the specimens were usually, but not always, smaller than those on the finish side.

FIGURE 19. EXPANSION AND CONTRACTION OF LATH AND PLASTER SPECIMENS FROM HOSPITAL BUILDING AS THE RESULT OF CHANGES IN RELATIVE HUMIDITY AND DAMPENING. THE NUMBERS OF SPECIMENS CORRESPOND TO ROOM LOCATIONS SHOWN ON THE BUILDING PLAN. SPECIMENS MARKED 7 AND 8 WERE FROM THE BASEMENT CORRIDOR.
